## ANALYSIS OF CAUSES OF PELLET MILL MATRIX WEAR BASED ON A SELECTED EXAMPLE

*This paper presents selected results of an analysis of damage causes to pellet mill matrix. The tested pellet mill matrix was used for the traditional technological process of pellet production. The tests were carried out since matrix failure times were found out to be too short. In order to assess the causes of matrix damage, tests of chemical composition and hardness of the matrix material were performed as well as observation of microscopic points of wear, analysis in the area of parameters of the process of operation and general conditions of use of the pellet mill. Discrepancies between the chemical composition of the material of the pellet mill and the information contained in the DTR were observed. Attention was paid to a possible influence of heat treatment and operating parameters on its premature damage.*

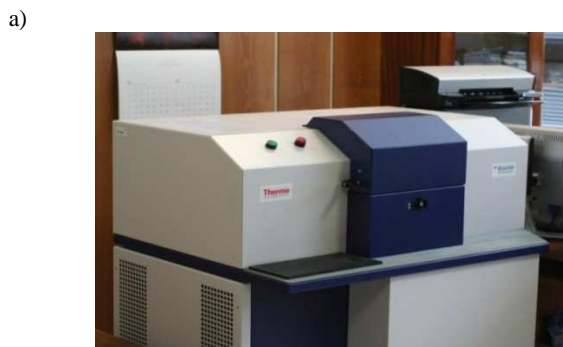
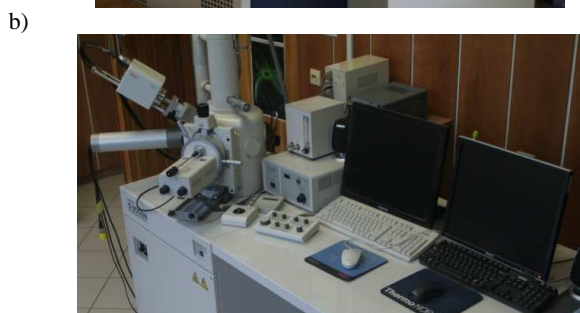
Fig. 3. View of: a) Thermo ARL Quantris emission spectrometer, b) Hitachi S-3000N scanning microscope  
Rys. 3 Widok: a) spektrometr emisyjny Thermo ARL Quantris, b) mikroskop skaningowy Hitachi S-3000N

Tests of chemical composition were carried out by means of Thermo ARL Quantis emission spark spectrometer (fig. 3a). Microscope observations of breakage points and metallographic specimens were carried out by means of Hitachi S-3000N scanning microscope (fig. 3b) with an X-ray microanalysis module. Hardness tests were carried out by means of SHR-187.50 hardness tester.

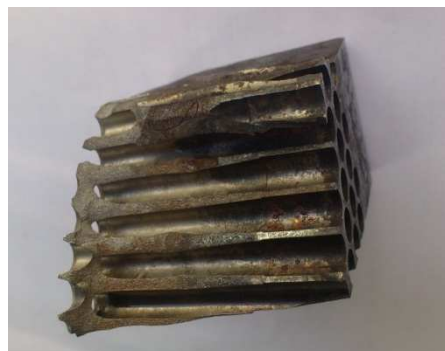
It can be added that the performed macroscopic observations allowed to identify a corroded structure on working surfaces and in breakage points of the matrix (fig. 9).

Fig. 9. Corrosion on working surfaces of the matrix  
Rys. 9. Korozja na powierzchniach roboczych matrycy

4. The most probable cause of matrix cracking is an inappropriate process of its heat treatment or inappropriate parameters of this process. Negligence in this area may result in, among others, hardening cracks, or pitting and intercrystalline corrosion, which lead to a complete damage to the material. The aforementioned high sulphur content should also be remembered as it creates compounds that lead to heat cracking.
