AN INFLUENCE OF CAR WASHING ON THE THICKNESS OF LACQUER COATING

Key words: car washing, lacquer coating, distribution of coating thickness

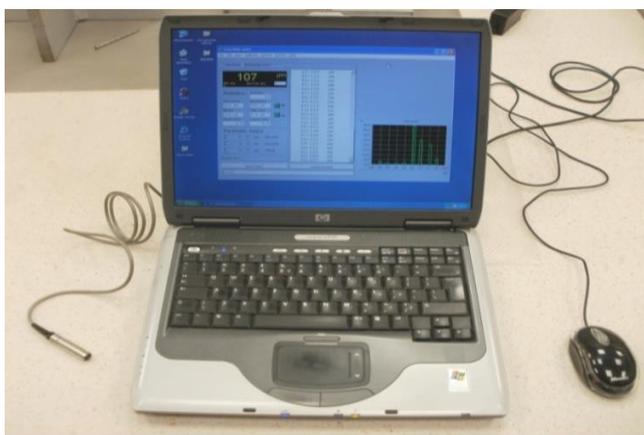
Fig. 1. KD-Leptoskop 2050 manufactured by Karl Deutsch
Rys. 1. Leptoskop KD 2050 – produkt firmy Karl Deutsch

The wear of the lacquer coating of the vehicle body fragment was assessed by change (distribution) of coating thickness. The investigation was carried out using two instruments, allowing for fast and accurate measurement of the thickness of the lacquer coating. KD-Leptoskop 2050 produced by Karl Deutsch Company was used with a simple probe 11.4 mm (Fig. 1) and Mini Test 730 instrument

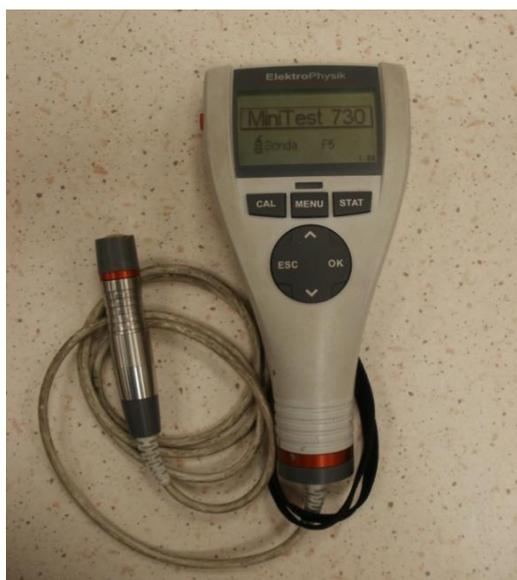
Fig. 2. The instrument MiniTest 730 manufactured by ElektroPhysik
Rys. 2. Przyrząd MiniTest 730 produkcji firmy ElektroPhysik

manufactured by ElektroPhysik Company with a probe on the cable (Fig. 2). This kind of instrument was already used to determination of lacquer coating thickness of the car body in various cases [3, 4].

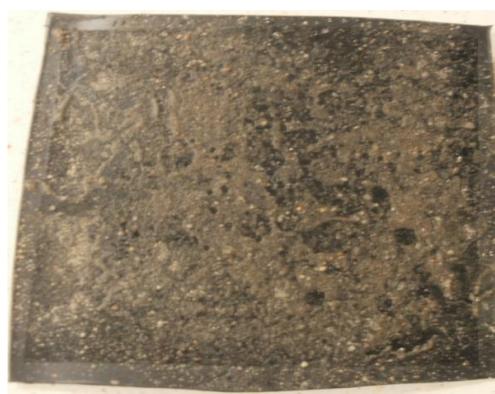
Fig. 3. A contaminated sample prepared for washing [5]
Rys. 3. Zanieczyszczona próbka przygotowania do mycia [5]

The thickness of the lacquer coating was measured every five washing cycles, respectively, before washing and after 5, 10, 15 and 20 washing cycles. The sample, before the first measurement was gently cleaned and washed with clean water using a soft cloth. The next step, after the initial series of measurements, included contamination of the sample surface by dust and road dirt during the cycle of urban ride (Fig. 3) [5].

Contaminated and dried sample was subjected to a manual washing with a sponge without using the pre-wash, involving rinsing and moistening the dirt by the jet of water under slight pressure. The sponge, as is during the typical washing process, was soaked with water. The process of washing during the investigations was not supported by any chemical means.

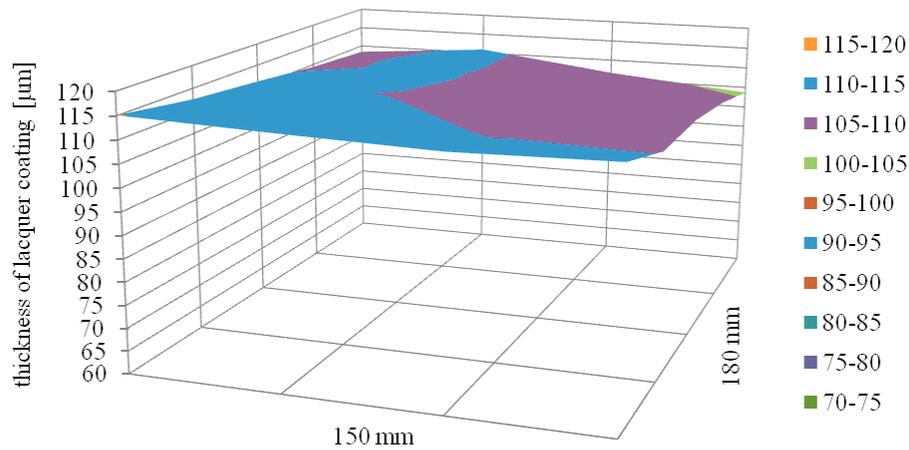
Fig. 4. Distribution of the thickness of the lacquer coating on a sample of car body sheet before washing operation, performed by the instrument KD-Leptoskop 2050

The results of the lacquer coating thickness measurements carried out on the prepared sample are shown graphically in Figs 4 to 10. Figures 4 and 5 show graphs of coating thickness at baseline, before washing. Figures 6 and 7 show examples of selected distributions of coating thickness in the final stages of the investigations.

Analyzing the graphs in Fig. 4 and 5, it can be concluded that the distributions of the thickness of the coating before washing contain the lacquer coating – in principle – only in two ranges of thicknesses. The thickness distributions of lacquer coating on the sample were similar in the case of using two different measuring instruments (Fig. 1 and 2), which positively determines the credibility of the results. After the last washing cycle, the uneven coating material losses on the sample was recorded (Fig. 6 and 7).

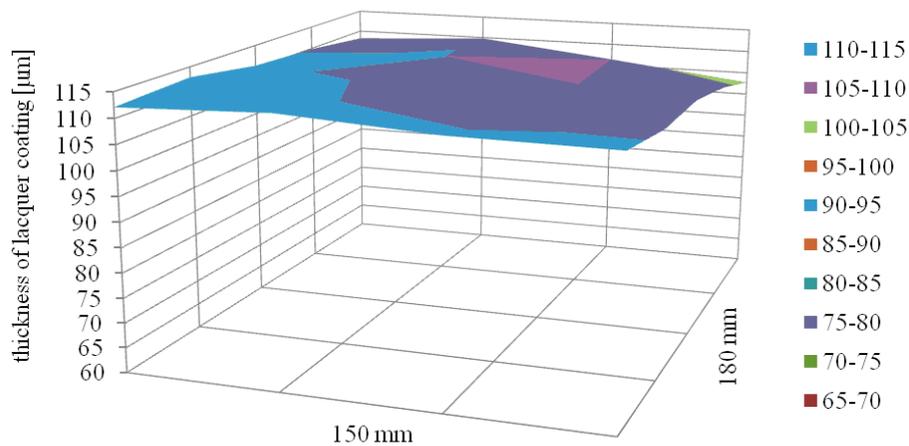
Fig. 5. Distribution of the thickness of the lacquer coating on a sample of car body sheet before washing operation, performed by the instrument MiniTest 730

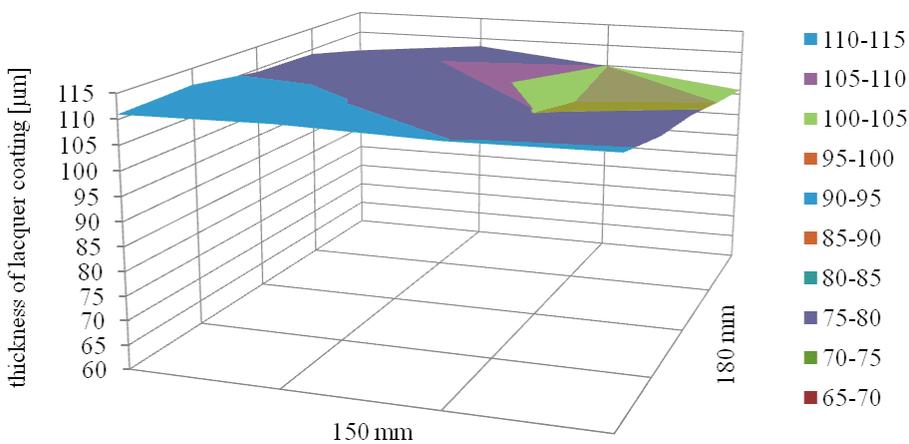
Fig. 6. Distribution of the thickness of the lacquer coating on a sample of car body sheet after fifth cycle of washing, performed by the instrument KD-Leptoskop 2050

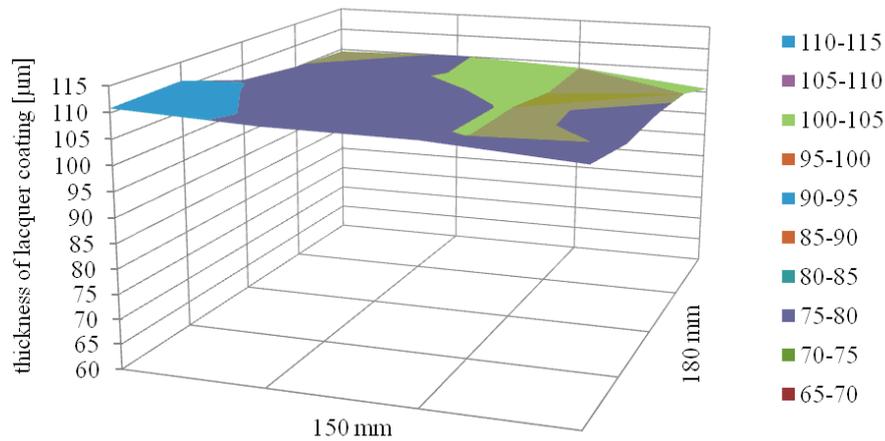
Fig. 7. Distribution of the thickness of the lacquer coating on a sample of car body sheet after fifth cycle of washing, performed by the instrument MiniTest 730

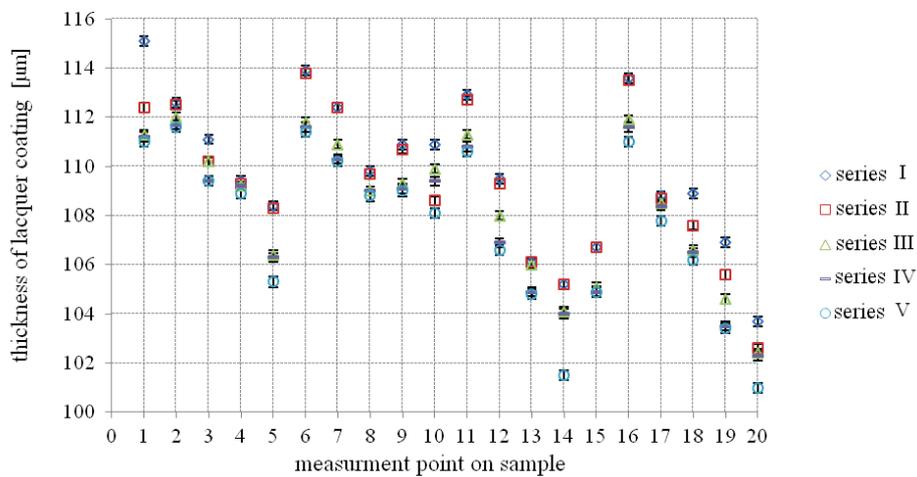
Fig. 8. Changes in average thickness of the lacquer coating determined by the instrument KD-Leptoskop 2050 for all measuring points in the particular series of measurements

Analyzing obtained (Fig. 8 and 9) graphs it should be noted that the greatest loss of coating material occurred at the measurement point number 9 of the sample and amounted to $4.86 \mu\text{m}$, which corresponds to 4.4% of the initial coating thickness at this point. The next points in terms of thickness loss of the coating was points 4 and 10 – respectively $4.72 \mu\text{m}$ (4.3%) and $4.66 \mu\text{m}$ (4.2%). Points of the sample with the smallest loss of the thickness of the lacquer coating were: point number 1, where the loss of thickness was $1.26 \mu\text{m}$, which corresponds to 1.1% of the initial coating thickness, then point 2, where the loss amounted to $1.64 \mu\text{m}$ (1.45% of the initial thickness) and point 7, wherein the loss was $1.68 \mu\text{m}$ i.e. 1.5% of the initial thickness of the lacquer coating. The resulting distributions of lacquer coating thickness obtained with the aid of two independent instruments before washing, during and after manual washing indicate a measurable decrease in the thickness of the lacquer coating on a specially prepared sample. In a better way, the loss of the lacquer coating material while washing illustrates the chart of the changes in average thickness of the coating in individual measuring series, registered after each washing cycles using two measuring instruments (Fig. 10).

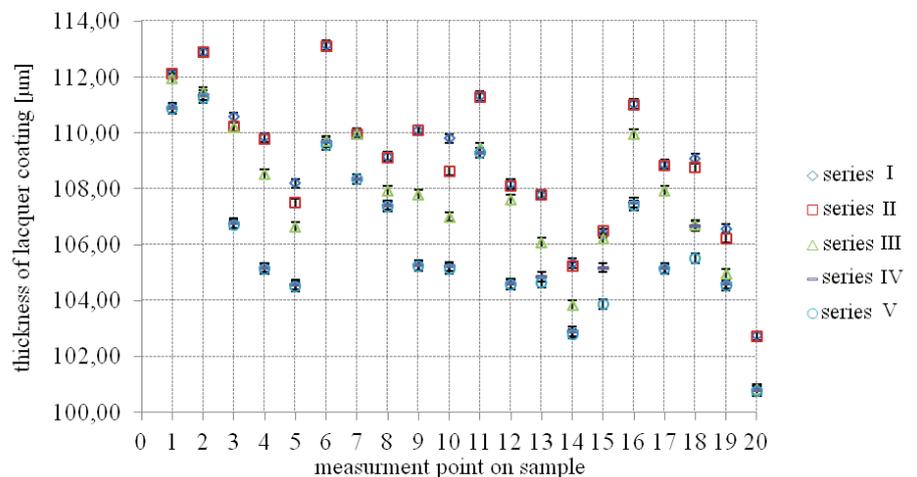
Fig. 9. Changes in average thickness of the lacquer coating determined by the instrument MiniTest 730 for all measuring points in the particular series of measurements

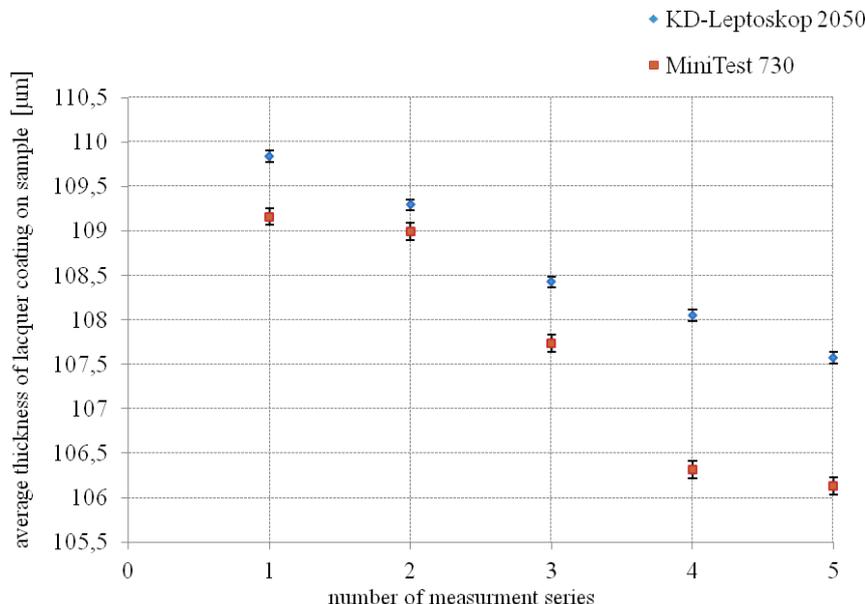
Fig. 10. A comparison of the average thickness of the lacquer coating determined by using two instruments in each series of measurements
